TRI-SERVICE CONFERENCE ON CORROSION

Electroplating and Epoxy Repair Methods for Corroded 70/30 CuNi and Alloy 400 Seawater System Components.

Mr. Timothy J. Jackovic*
Mr. Edward B. Bieberich

Carderock Division
Naval Surface Warfare Center
Code 613
3A Leggett Circle
Annapolis, MD 21402-5067

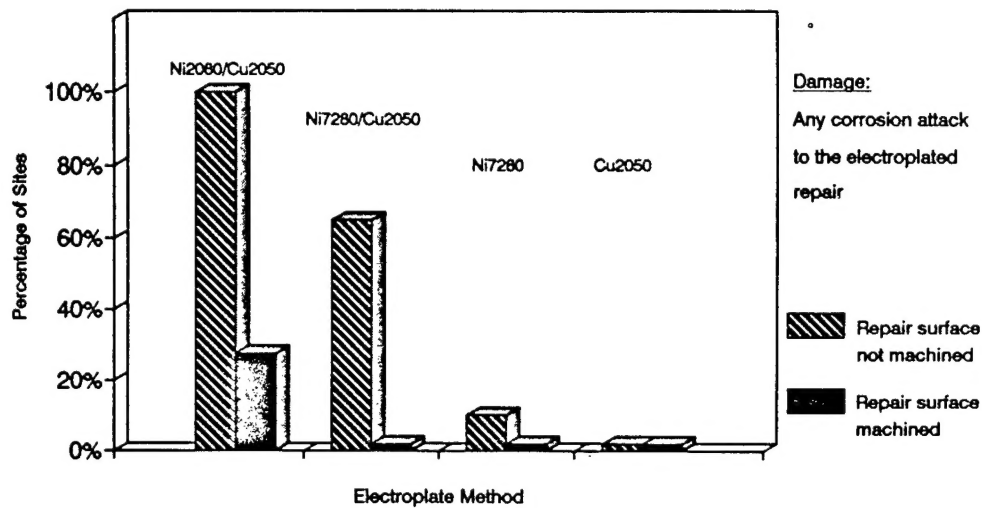
The electroplate repairs were considered to have failed when any corrosion damage occurred to the electroplate. Results of this evaluation are provided in Figure 3.

Figure 3: Results of electroplate repair corrosion tests.

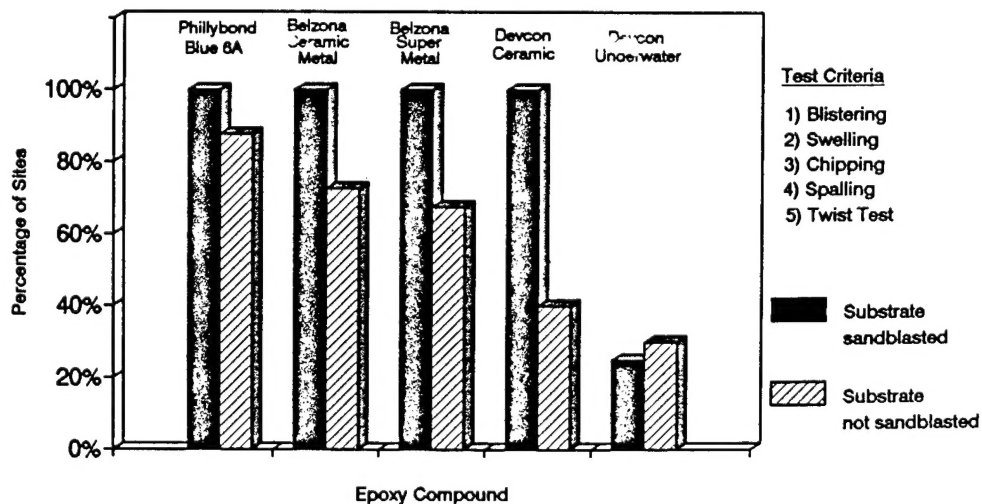
The epoxy coatings were rated as having passed or failed based on the following conditions for failure: blistering, chipping, spalling, swelling, or movement of the coating. The coatings were also considered failures if they could be twisted off by hand. The results of this inspection are provided in Figure 4.

Figure 4: Results of epoxy repair corrosion tests.

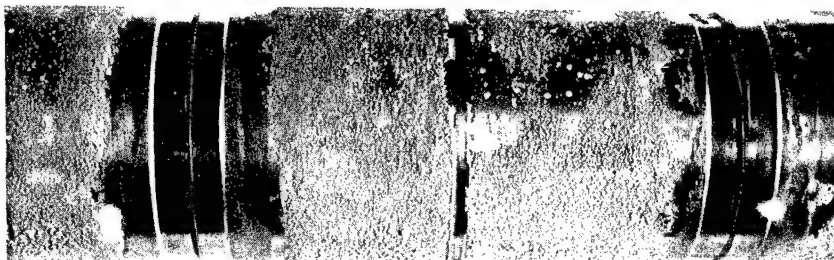
Cu2050 performed poorly as an O-ring sealing surface repair on both 70/30 CuNi and alloy 400. Cu2050 was found to be less noble than either substrate material and subsequently the O-ring seal area was damaged by galvanic corrosion, Figure 5. The corrosion was most severe adjacent to the O-ring which suggests that crevice corrosion was also a factor. Cu2050 was able to suppress some corrosion of the substrate, including reduced attack at the control sites. However, once the copper was sufficiently depleted, crevice corrosion of the substrate initiated. Electroplating with copper over a large surface area may suppress corrosion for a limited time, but the electroplate will galvanically corrode away leaving the original damaged area. It is recommended that Cu2050 not be used as a repair method on 70/30 CuNi or alloy 400.

Figure 5. Control site (middle) and corroded electroplated sites on alloy 400 specimen electroplated with Cu2050.

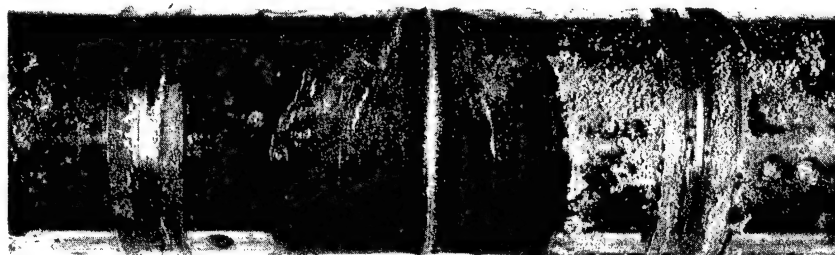
Ni2080 with a Cu2050 preplate performed best of the electroplated repair specimens, Figure 6. The only damage on the electroplating repairs was seen on the finished PH specimens. Machining of these specimens reduced the thickness of the nickel cap to a level insufficient to blanket the entire copper preplate. By adjusting the procedure to specify a minimum cap thickness, this problem should be avoidable. In addition, Ni2080 without a preplate applied to alloy 400 has previously been recommended for repair of corrosion in alloy 400 and 70/30 CuNi metal-to-metal crevices. Omitting the copper preplate guarantees that the electroplate will not fail from exposure of copper. However, a Cu2050 preplate is sometimes used since it is easier to deposit and thicker layers can be applied before additional surface preparation (reactivation) is required. The maximum one layer buildup before reactivation is 0.007 in. for Ni2080 and 0.015 in. for Cu2050 [3]. If feasible, the Ni2080 should be used without a preplate. However, if a preplate is necessary, a minimum Ni2080 cap thickness of 0.004 in. should be maintained over the entire preplate after finishing the surface is completed. This is to ensure that no copper is exposed at the surface of the repair. It is recommended that a fleet evaluation be performed of Ni2080 electroplate repair of either alloy 400 or 70/30 CuNi components.

Figure 6. Control site (middle) and electroplated sites on alloy 400 specimen electroplated with Ni2080 (Cu2050 preplate).

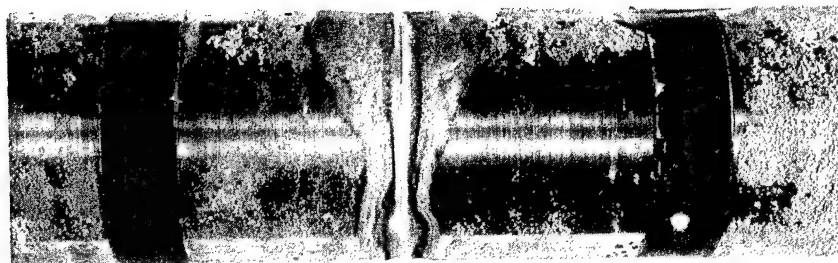
The PS specimens which had the grooves sandblasted prior to application of the epoxy showed superior resistance to failure. When sandblasted, 4 of the 5 epoxies had no failures on type I specimens. A representative specimen showing the good performance of epoxy is shown in Figure 7. Surface preparation is extremely important when applying mechanically bonded materials [2]. The roughened surface produced from sandblasting significantly increases the bond strength and therefore provides a longer lasting coating. Wherever feasible, it is recommended that sandblasting be done on all surfaces which are to be repaired by epoxy. Methods to sandblast limited access areas (eg., narrow width O-ring grooves) and to sandblast small areas on components aboard ship (without grit dust in the air) should be developed.

Figure 7. Control site (middle) and epoxy repaired sites on alloy 400 specimen repaired with Phillybond Blue 6A.

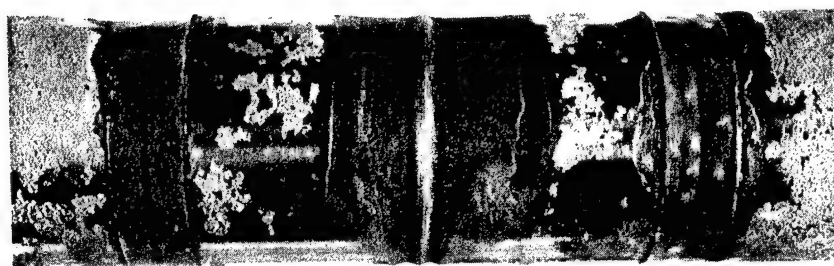
Most failures of epoxy coatings were seen on unsandblasted and type II specimens. These failures were caused by poor adhesion of the coatings allowing seawater to leak under the coatings. The Devcon Underwater had the worst performance of any of the epoxy repairs, Figure 8. Seawater leakage under this coating caused blistering and spalling of the coating. Of the 80 sites that were repaired with Devcon Underwater, 58 failed. Sandblasting of the grooved surface did not improve this coating's resistance to failure.

Figure 8. Control site (middle) and blistered epoxy repair sites on alloy 400 specimen repaired with Devcon Underwater.
